Subject: Tuolumne River Water Diversion at La Grange Powerhouse

During the 2008 annual Chinook salmon escapement survey, Department of Fish and Game biologists observed an alteration of river flow resulting from the rerouting of water at the La Grange powerhouse.

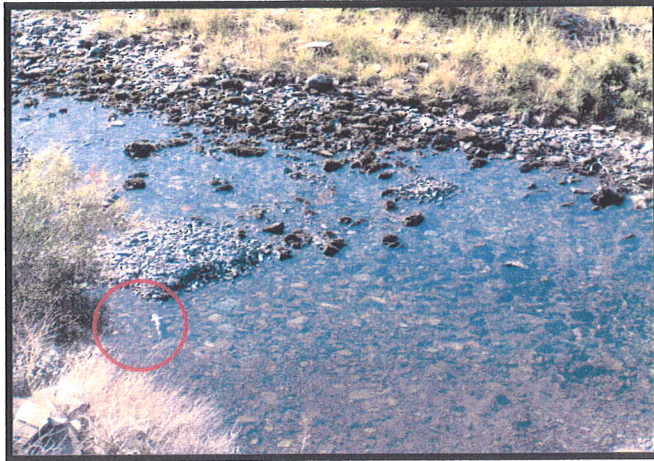
Figure 5. Redd location and a female carcass in the powerhouse channel with minimal flow following the re-routing of water during the November 4, 2008 survey.

Surveys conducted on riffle A1, which is located in the powerhouse channel immediately downstream of the La Grange powerhouse (Figure 4), documented redds and spawning activity beginning on October 22 for the 2008 escapement survey season. Prior to the rerouting of water, ten live fish and three visible redds were observed in riffle A1 (October 22) while the number of redds increased to seven the following week when the section was surveyed on October 28. Following the rerouting of water during the November 4 survey, the number of redds decreased to five, and three live fish were observed in the powerhouse channel with minimal flow. A female carcass that appeared to have spawned was recovered, tagged, and released back into the river (Figures 5 and 6).

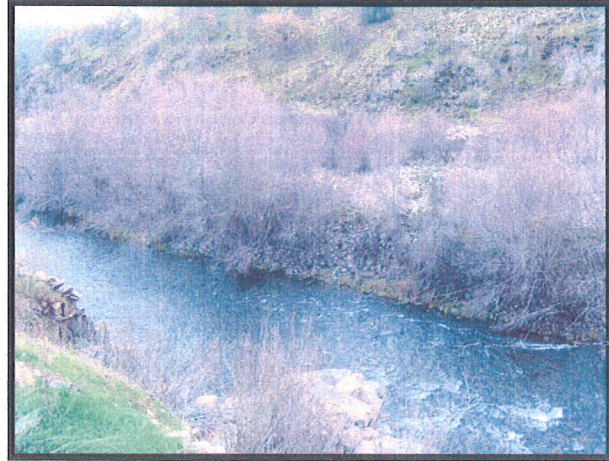
Figure 8. Comparison of powerhouse channel during normal flow. (169 cfs based on USGS La Grange flow gage data). January 15, 2009.
