2005 LOWER TUOLUMNE RIVER ANNUAL REPORT

Bobcat Flat/River Mile 43: Phase I Project Completion Report

McBain and Trush Arcata, CA

Bobcat Flat RM 43 - Phase I As-Built Monitoring Final Report

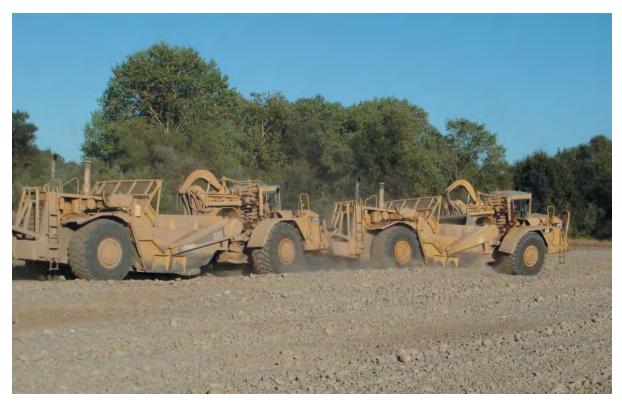
Figure 2. Two Caterpillar 627G scrapers working in tandem while excavating material from floodway (Photograph courtesy of Friends of the Tuolumne).

Dredge tailing excavation began on August 23 and was completed on September 9, 2005. Two Caterpillar 627G scrapers (each with 22 yd³ capacity) operating in tandem were used to excavate dredger tailings from the floodplain restoration area and transport excavated material to stockpiles (Figure 2). After the scrapers removed the tailings and achieved rough grade, a Caterpillar 14H motor grader bladed the ground to finished elevations (Figure 3). While grading, the grader transmitted to a grade laser receiver mounted on the back of a work truck to confirm finished elevations. McBain & Trush, Inc. also spot checked floodplain elevations using a total station during construction.

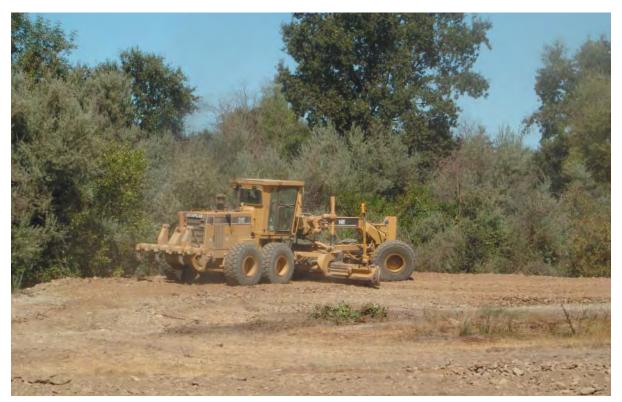
Figure 3. Caterpillar 14H grader providing final grading elevations (Photograph courtesy of Friends of the Tuolumne).

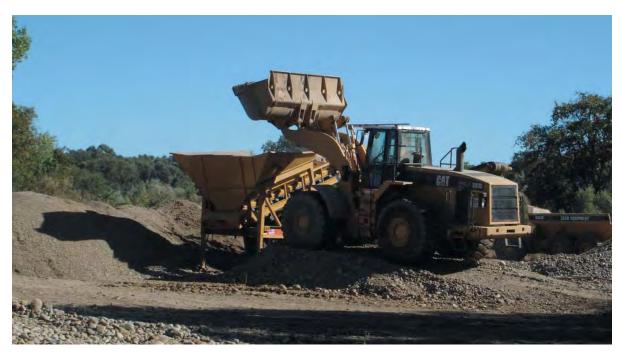
Figure 4. Caterpillar 980G front end loader placing raw material from stockpile into hopper for sieving and washing (Photograph courtesy of Friends of the Tuolumne).

Stockpiled material tailings were transported to the sieving and washing plant by a Caterpillar 980G front-end loader (Figure 4). The sieving and washing plant consisted of a diesel-powered Construction Equipment Co. (CEC) Screen-It, retrofitted with a washing system that sprayed water through three fire nozzles aimed at the screen (Figure 5). The loader filled the sieving plant hopper with raw excavated tailings. From the hopper, tailings were conveyed on a belt to a 5-inch screen to

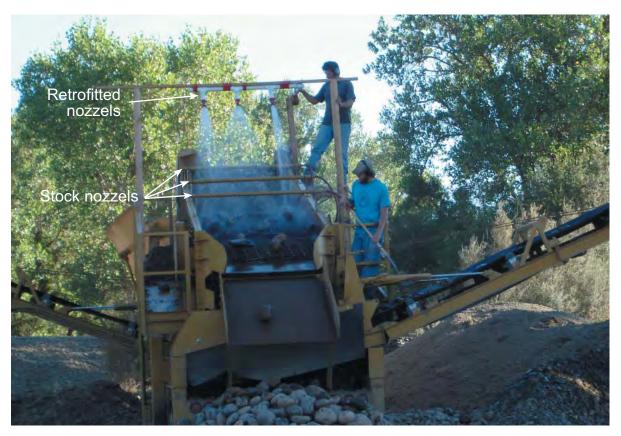
Figure 5. Sieving and washing plant consisting of Construction Equipment Co. (CEC) Screen-It, diesel powered screener, retrofitted with an additional washing system that sprayed water through three fire nozzles aimed at the screen (Photograph courtesy of Friends of the Tuolumne).

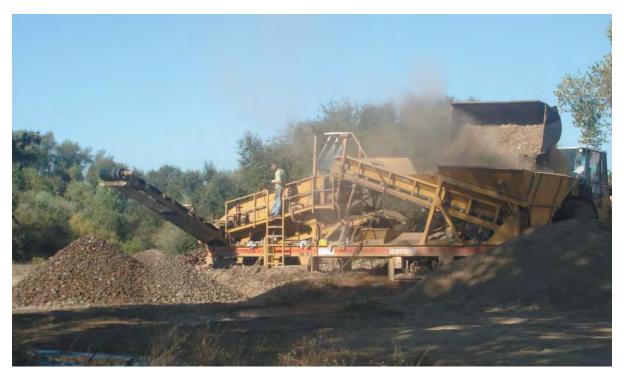
Figure 6. Resulting ¹/₄ to 5 inch sieved washed coarse sediment ready for placement in channel (Photograph courtesy of Friends of the Tuolumne).

remove larger clasts. Material passing through the 5-inch screen was then passed over a ¹/₄-inch screen to remove sand and silt (Figure 6).

The majority of the sieved and washed coarse sediment placed into the channel was comprised of dredger tailings that passed a 5-inch square screen and was retained by a ¼-inch square screen. Prior to processing the ¼-inch to 5-inch material, 800 yd³ of tailings ranging in size from ¼ to ¾-inch was sieved, washed, and set aside to be mixed into the ¼ to 5-inch material, as needed to meet coarse sediment gradation targets.

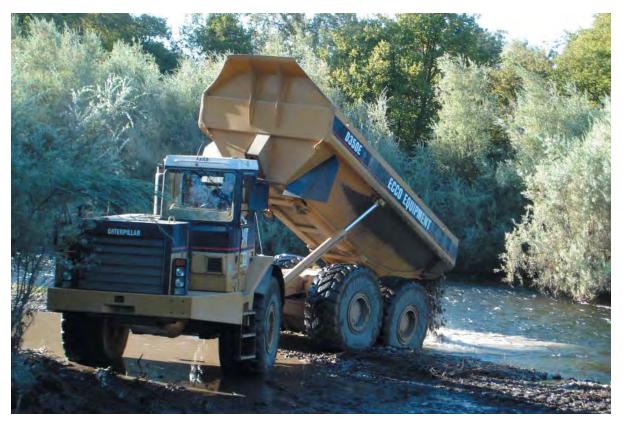
Figure 7. Caterpillar D350E (21 yd³) articulated truck dumping coarse sediment at Patch 2 (Photograph courtesy of Friends of the Tuolumne).

In-channel construction began on August 23, 2005 and was completed on September 19, 2005. Screened and washed coarse sediment was loaded into a Caterpillar D350E articulated truck (22 yd³ capacity), hauled to the river, and stockpiled within the augmentation patch boundaries (Figure 7). Stockpiled coarse sediment was placed in the river using a Hyundai 770-7 front end loader (Figure 8). The loader was also used to rework the placed sediment to the desired finished surface. Coarse sediment was placed under the supervision of FOT. During construction, McBain & Trush, Inc. checked riffle (hydraulic control) elevations and slopes to assist FOT in maintaining consistency with the design (Figure 9), with the acknowledgement that some field adjustments would likely occur.

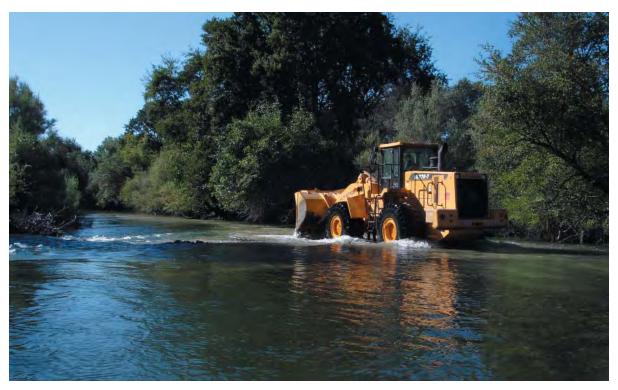
Figure 8. Hyundai 770-7 front end loader placing and grading coarse sediment at Patch 3 (Photograph courtesy of Friends of the Tuolumne).

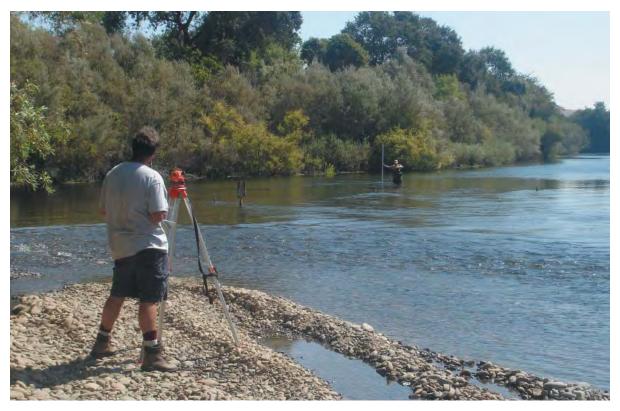
Figure 9. Checking riffle crest elevations at Patch 1 prior to completing in-channel construction (Photograph courtesy of Friends of the Tuolumne).

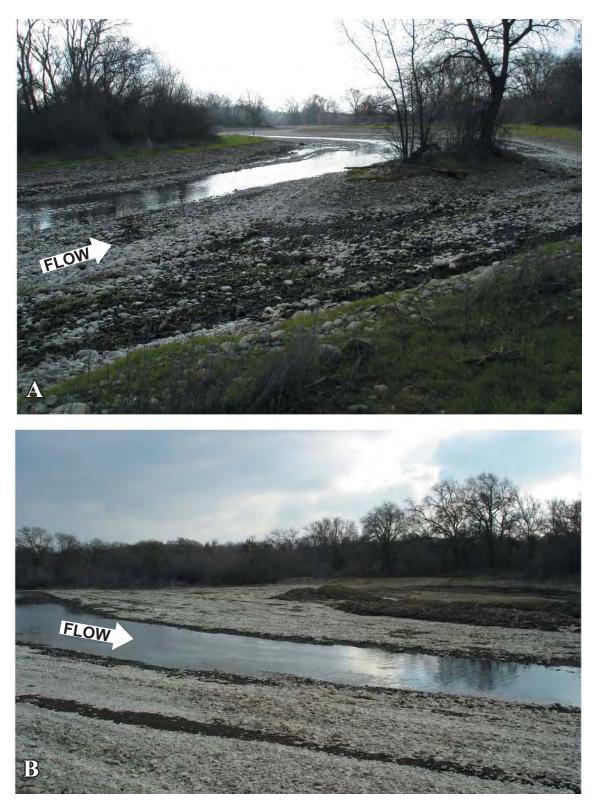
Figure 18. As-built high flow scour channel showing conveyance of flows from groundwater seepage during a dam release of 3,150 cfs. Photograph A) taken along the right side of the as-built floodplain at Station 16+00 looking downstream. Photograph B) Taken along the right side of the as-built floodplain at Station 16+50 looking back towards the main channel (Photograph courtesy of Friends of the Tuolumne).

- Floodplain excavation was narrowed by an average of 75 feet between floodplain station 2+00 and 10+00, and the high flow scour channel was reduced by one foot in depth and 10 feet in width to reduce excavation volume to amounts consistent with the project bid and contract. Though the high flow scour channel construction deviates from the design, the purpose and function of the channel, (i.e. to reduce fish stranding), is achieved because the floodplain drains as designed (Figures 17 and 18).
